MISSISSIPPI ENVIRONMENTAL GEOLOGY

David T. Dockery III and David E. Thompson

Mississippi Department of Environmental Quality
Office of Geology
Second Edition, 2019

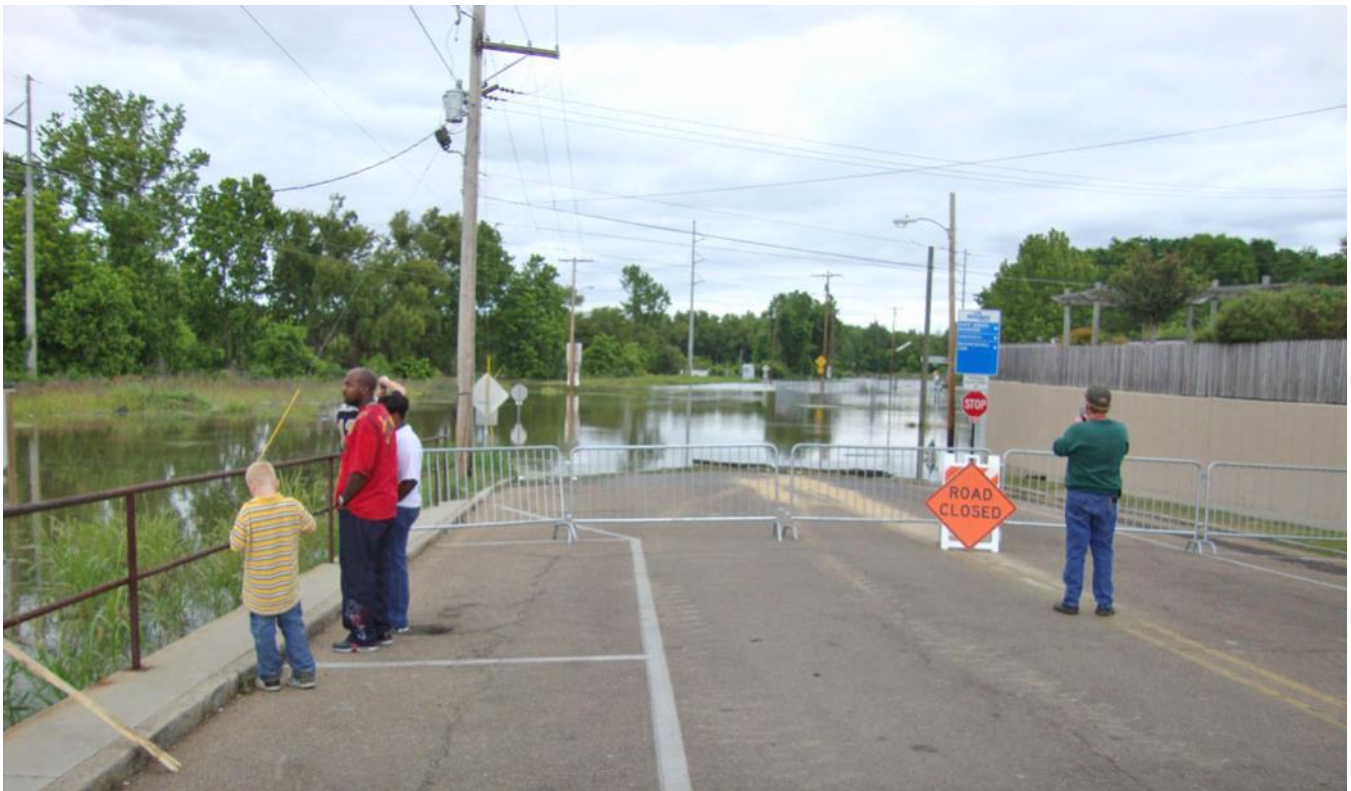
Figure 83. Flood waters submerge Highway 61 in Vicksburg. Picture (digital; Image 1880) was taken on May 16, 2011.

The flood gates at Vicksburg were planked all the way to the top in preparation for the Great Flood of 2011. This planked closure had to be extended along the north end of the flood wall (**Figure 79**). Photographing the rising crest on the flood wall in 2011 (**figures 80-81**) required a 24-foot extension ladder and Homeland Security clearance from Vicksburg Emergency Management Director Anna Booth and notification of Lieutenant Davey Barnett of the Vicksburg Police Department. The Great Flood of 2011 not only covered Highway 465 (**Figure 82**) but also sections of Highway 61 (**Figure 83**) and many homes and businesses (**Figure 84**). With a crest of 57.1 feet

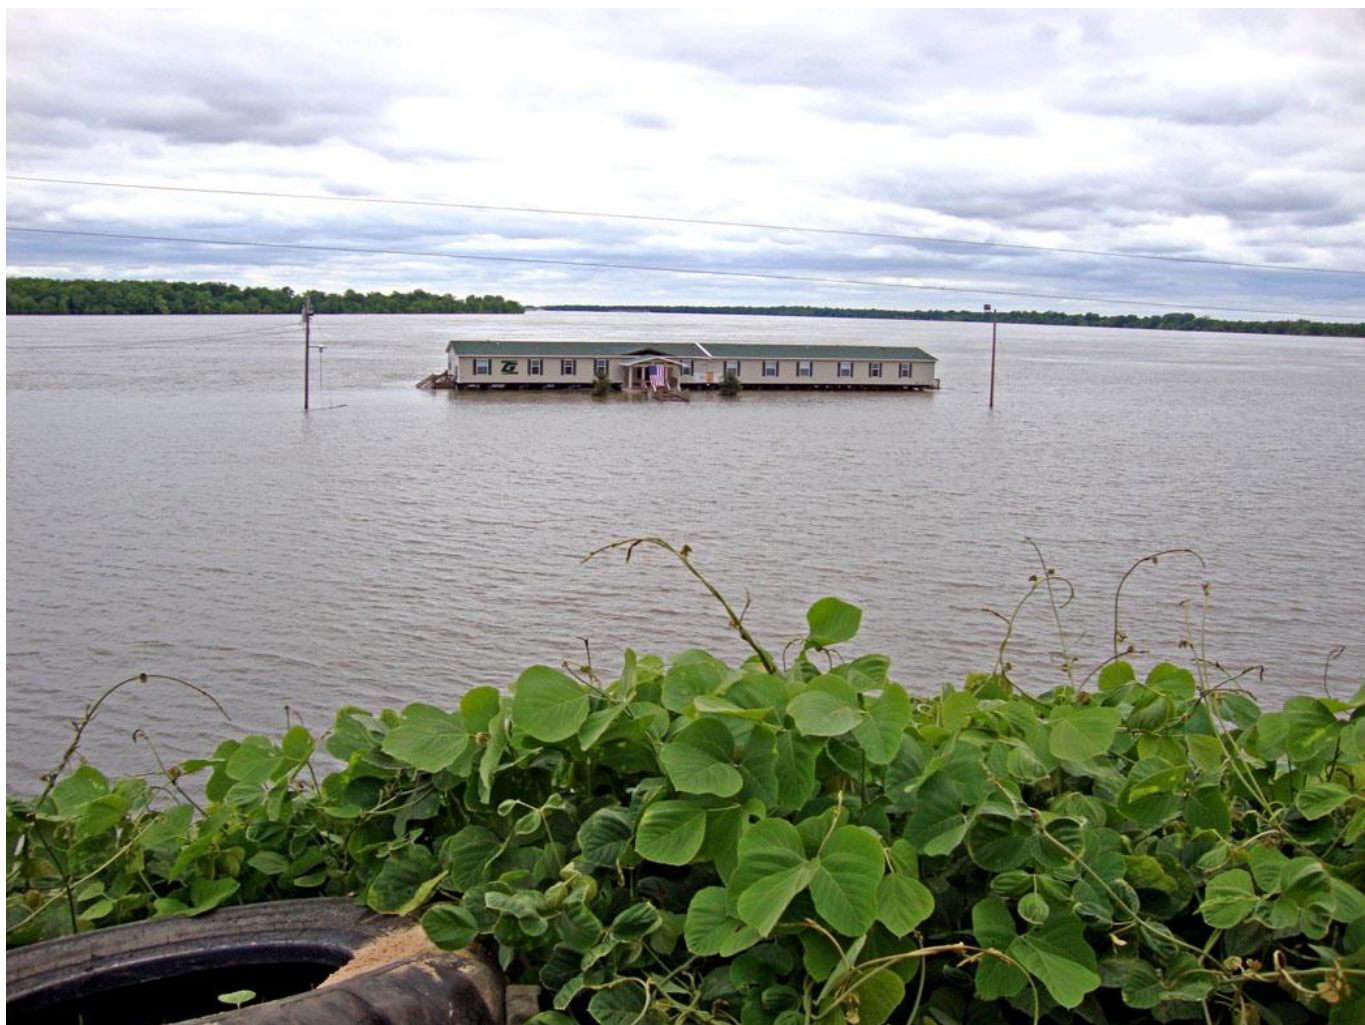
84. Flood waters of the Mississippi and Yazoo rivers merge at their confluence and extend their shores to the bluff line at Vicksburg, leaving a jacked-up office building surrounded by the swift currents of the Mississippi River (behind) and the backwaters of the Yazoo River (in front). Picture (digital; Image 1881) was taken on May 16, 2011.

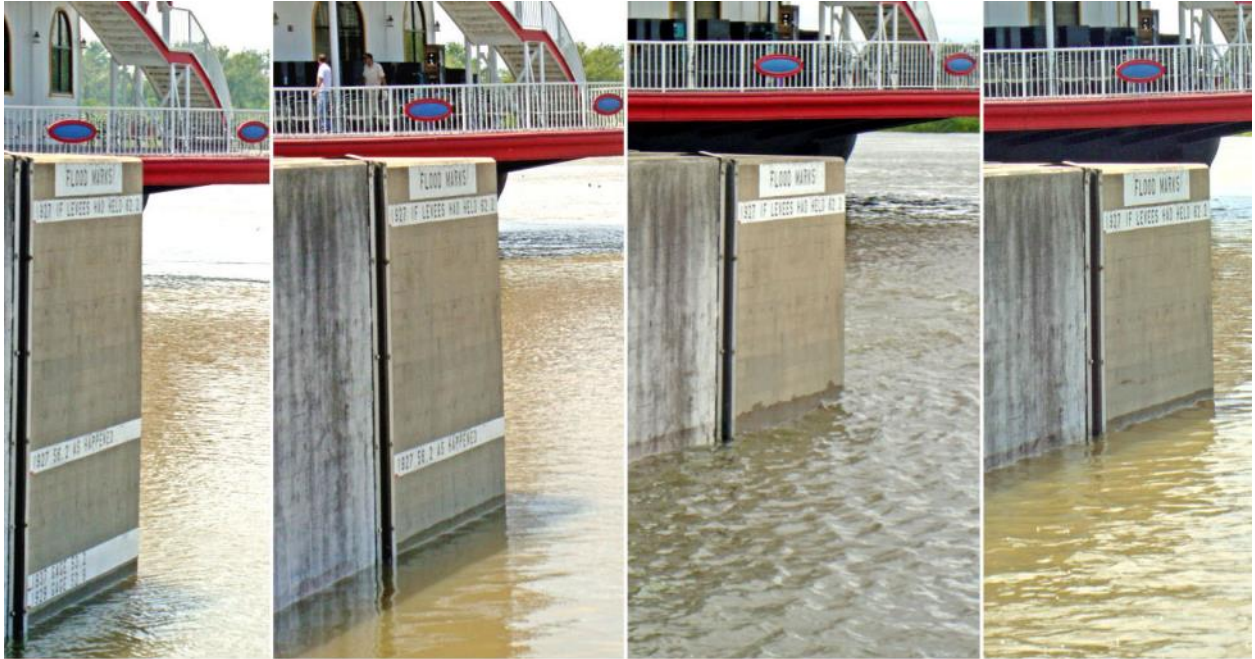
Figure 85. The rising tide of the Great Flood of 2011, climbing the Vicksburg flood wall. From left to right, pictures were taken around noon on: (1) May 9 below the 1929 flood crest of 52.9 feet, (2) May 11 below the highest recorded flood crest in 1927 of 56.2 feet, (3) May 16 above the 1927 flood crest, and (4) May 19 at a record crest of 57.1 feet. The bolt above and left of the 1927 mark was at water level on May 16 (3) and below water level on May 19 (4). Picture (digital; Composite image 1875).

on the evening of May 18, it is now the highest flood level ever recorded at Vicksburg (**Figure 85**)

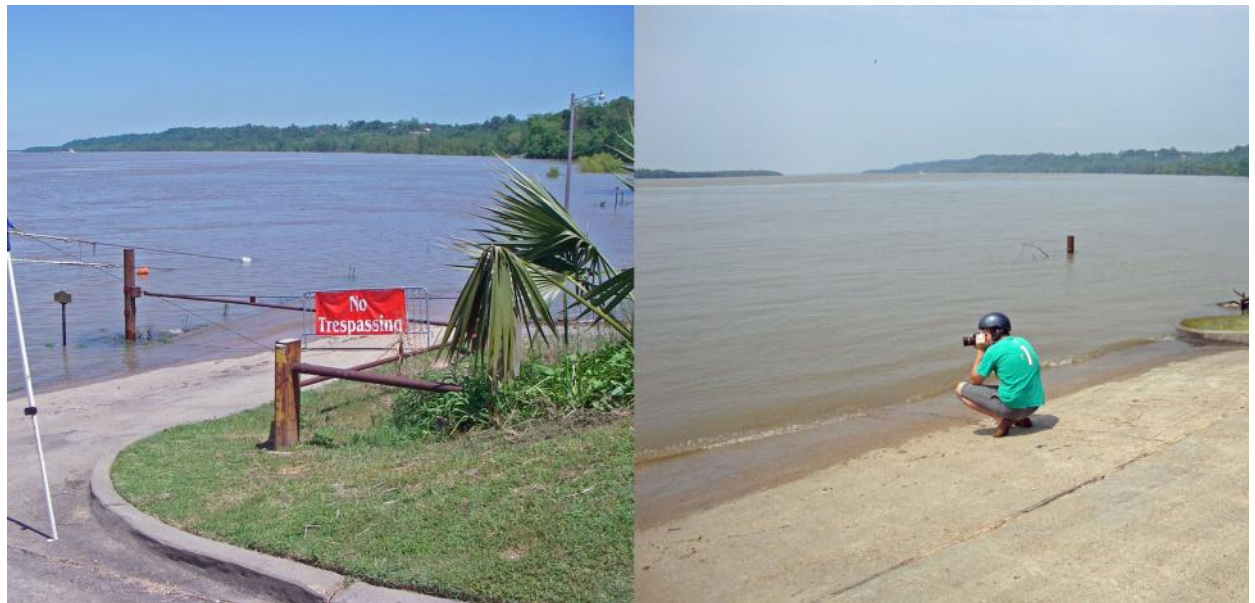
Figure 86. Left, flood crest at Natchez Under the Hill on April 21, 2008, water is at the base of the lower gate post; the upper gate post at the curb is high and dry. Right, flood crest at Natchez Under the Hill on May 21, 2011, water is at the base of the upper gate post; the lower gate is covered except for the top of the gate post. Picture (digital; Composite image 1876).

The Great Flood of 2011 continued its record breaking crests downstream with a crest of 61.8 feet, or 13.8 feet above flood stage, at the City of Natchez on May 21, a level significantly below the predicted crest of 64 feet. The previous record at Natchez was 58.04 feet set on February 21, 1937. **Figures 86 and 87** compare Natchez under the Hill during the flood crests of April 21, 2008, at 57.03 feet, and May 21, 2011, at 61.8 feet. On April 21, 2008, backwater flooding north of Natchez in the Port Gibson area was so high that Highway

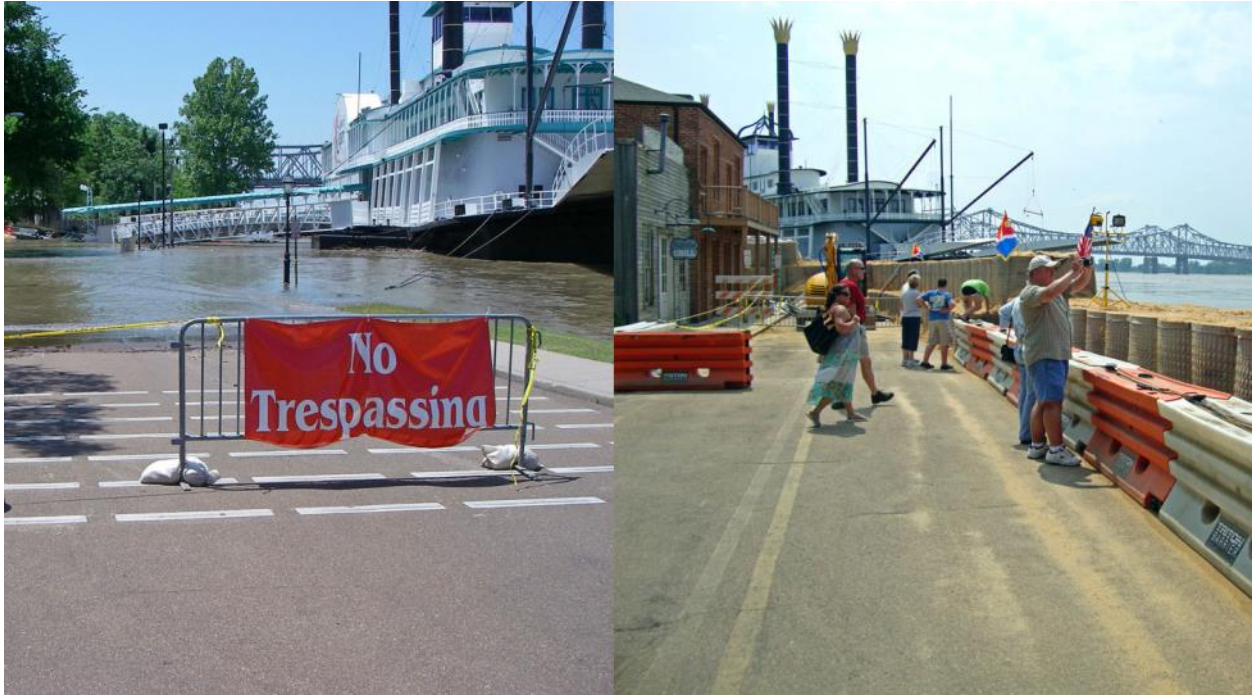
Figure 87. Left, flooded street at the Isle of Capri landing in Natchez Under the Hill on the April 21, 2008, flood crest. Right, make-shift levee built around the Isle of Capri low spot and against the river, as seen on the May 21, 2011, flood crest; businesses inside the levee remained open. Picture (digital; Composite image 1882).

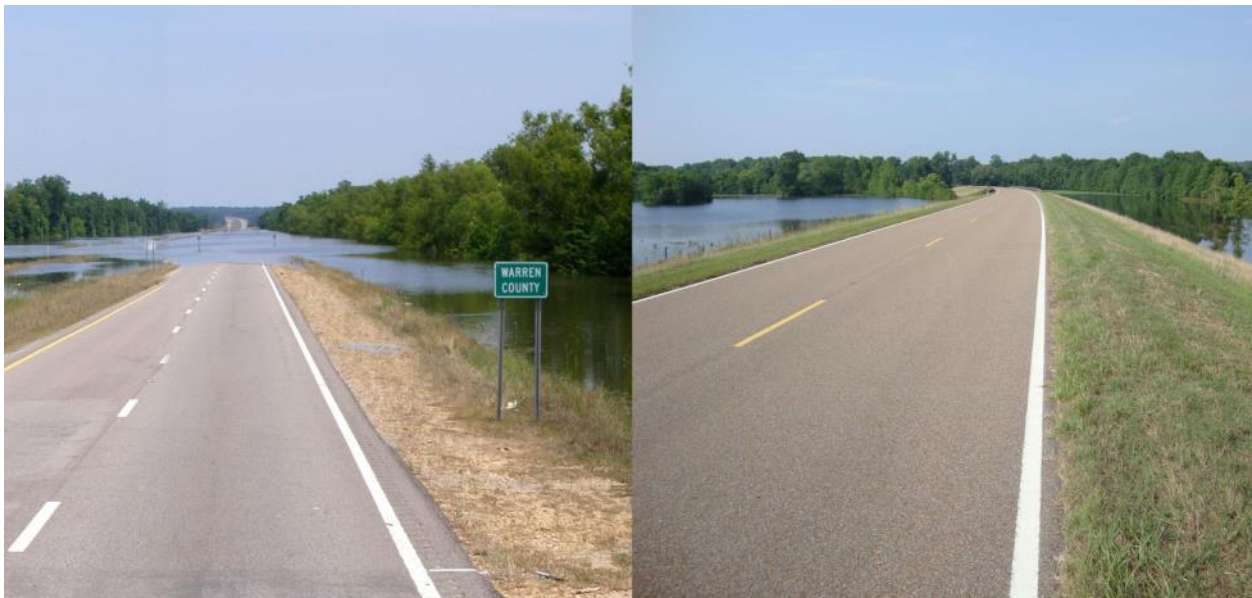
Figure 88. Left, backwater flooding on Highway 61 in Warren County just north of the Big Black River bridge. Right, backwater flooding on the Natchez Trace Parkway just south of the Bayou Pierre River bridge. Picture on left was taken on May 18, 2011, by James Matheny; picture on right was taken on May 21, 2011, by David Dockery. Picture (digital; Composite image 1883).

61 was flooded just north of the Big Black River bridge and fields on both sides of the Natchez Trace Parkway were flooded just south of the Little Bayou Pierre bridge (**Figure 88**).

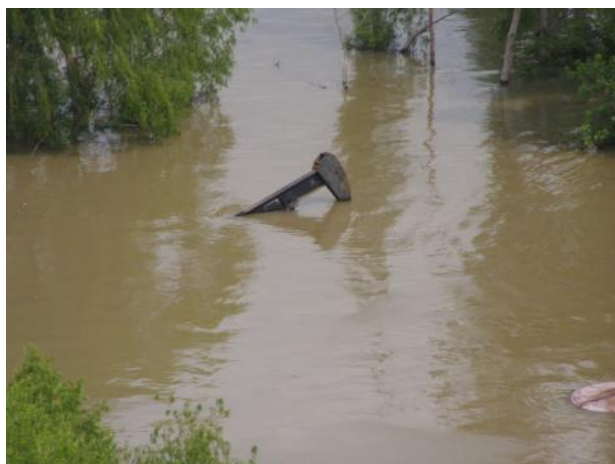
Figure 89. A flooded oil-well pump below Learned Hill at Natchez, Mississippi. Picture (digital; Image 1886) was taken by James Matheny on May 20, 2011.

lines, and oil storage tanks. **Figures 79-82** were taken by James Matheny who represented the Mississippi Department of Environmental Quality in a survey of the condition of flooded oil field equipment. **Figure 89** shows the top of an oil well pump above flood waters below Learned Bluff at Natchez, Mississippi. **Figures 90-92** illustrates the work in placing bags of cement on top of Biglane Operating's oil storage tanks to keep the tanks from floating away in the river currents.

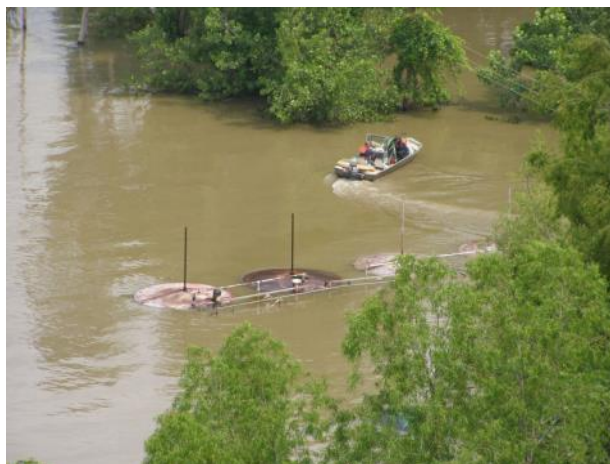
Figure 90. Flooded oil storage tanks for Biglane Operating wells below Learned Bluff at Natchez, Mississippi. Picture (digital; Image 1887) was taken by James Matheny on May 20, 2011.

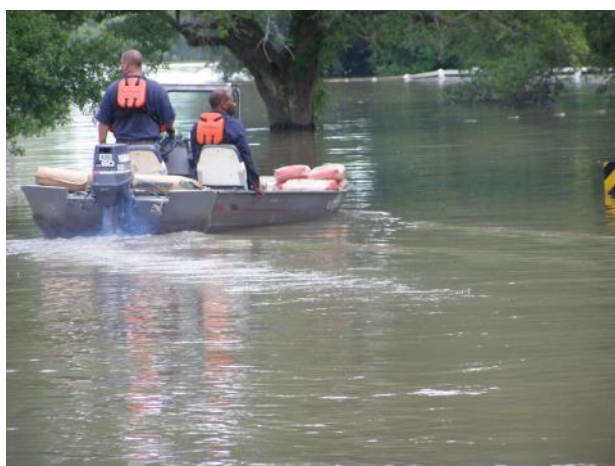
Figure 91. A jon boat carries bags of cement to weight down the tops of Bigland Operating's oil storage tanks below Learned Bluff at Natchez, Mississippi, in an effort to protect them from barge wakes, which might release oil by loosening pipe fittings. Picture (digital; Image 1888) was taken by James Matheny on May 20, 2011.

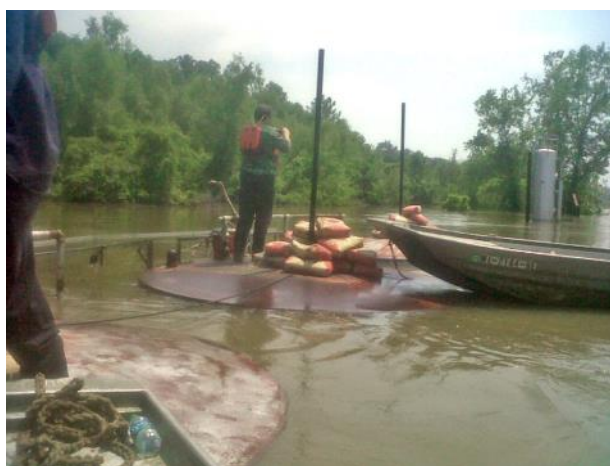
Figure 92. Placing bags of cement on Biglane Operating's flooded oil storage tanks below Learned Bluff at Natchez, Mississippi. Picture (digital; Image 1889) was taken by James Matheny on May 20, 2011.

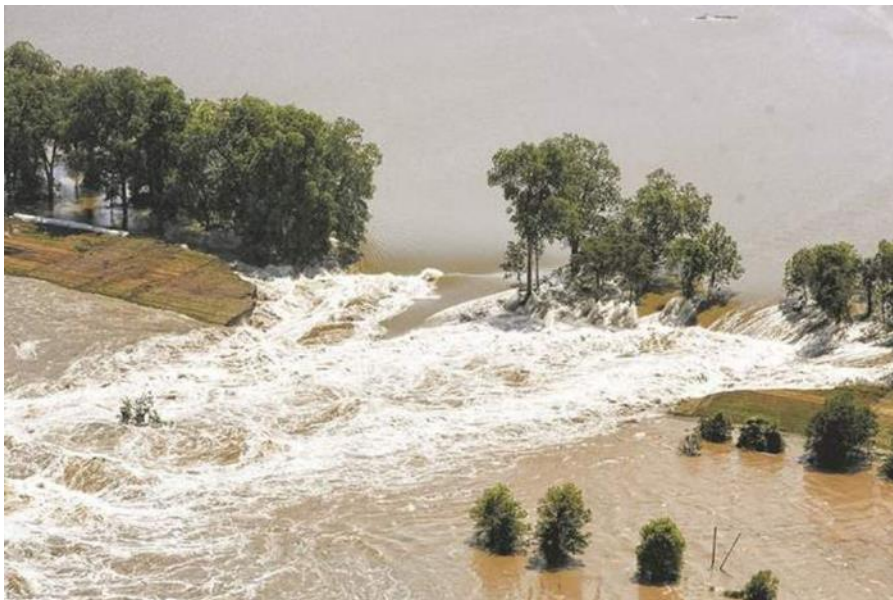
Figure 94. Left, failure of a secondary levee protecting 10,000 acres of farmland at Bunches Bend in East Carroll Parish, Louisiana, on May 13, 2011. A U.S. Army Corps of Engineers official was quoted as saying that when the levee failed, the Mississippi River level temporarily fell a half-foot at Greenville, Mississippi. This is the first breach of the levee since its construction by the Corps in 1912. Photograph from News-Star file photo. Image 1895.

On May 13, a secondary farm levee failed at Bunches Bend in East Carroll Parish, flooding 10,000 acres of prime Louisiana farmland (**Figure 94**), wiping out \$10 million in crop revenue, and excavating an 80-foot-deep hole in farmland at the breach site. A U.S. Army Corps of Engineers official was quoted as saying that when the levee failed, the Mississippi River level temporarily dropped a half-foot at Greenville, Mississippi (**Figure 95**). This was the first breach of the levee since its construction by the Corps in 1912. Failure of the Bunches Bend levee lowered the flood crest at Vicksburg enough to prevent the overtopping of the Yazoo Backwater Levee and the flooding of additional farmland in Mississippi (**Figure 96**).

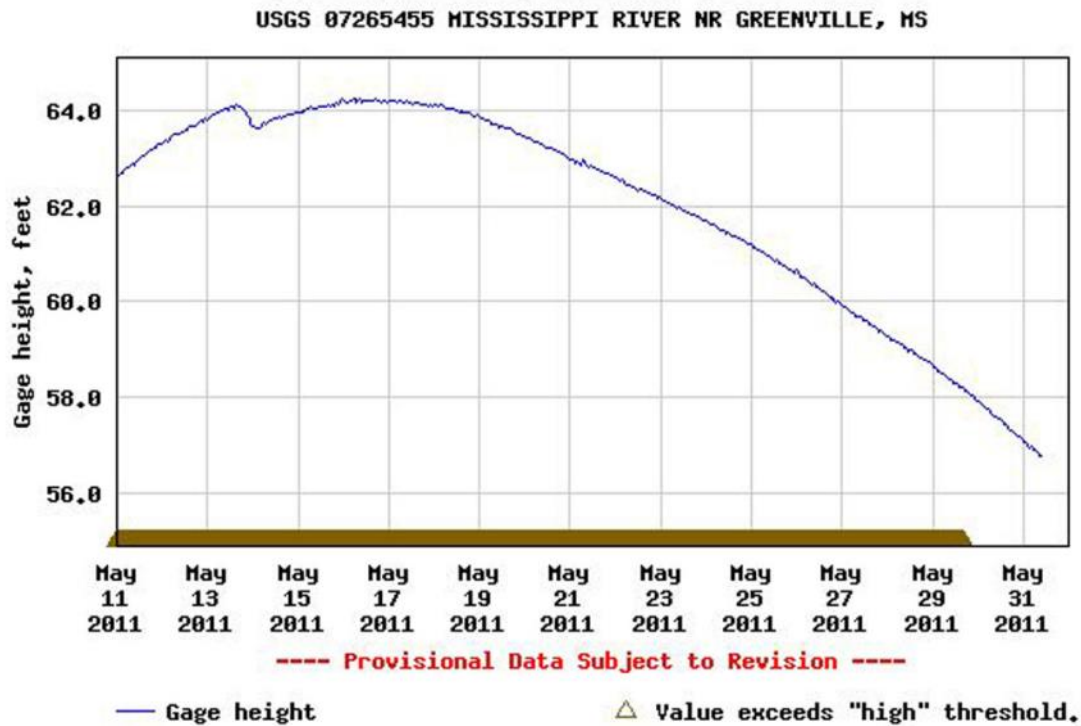
Figure 95. Mississippi River flood crest recorded on the gage at Greenville, Mississippi (graph from Jared Wright, USGS). The flood level dropped half a foot at Greenville on May 14 after the failure of the Bunches Bend farm levee on May 13, 2011. Image 1896.

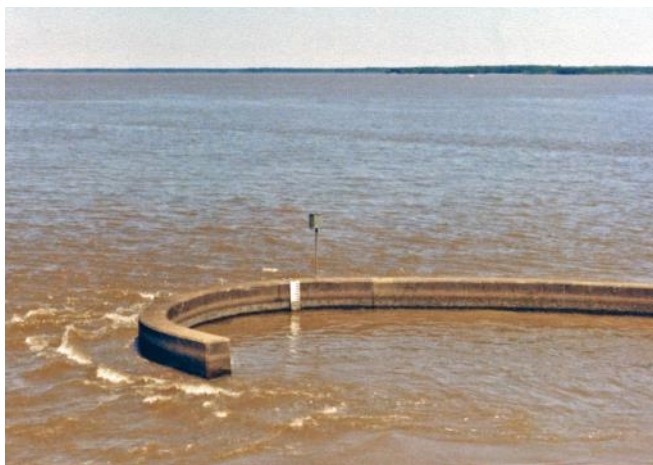
Figure 98. Concrete skirt that directs Ross Barnett Reservoir waters into the spillway on the spillway's west side. The mud level on the white gage shows the water level to have risen within 1.6 feet of the top of the skirt before the opening of the spillway to maximum outflow. Picture (scanned print 414-2; Image 1899) was taken on April 15, 1979.

On Saturday, flood waters raised the lake level of the upper reservoir to a point that shoreline homes were flooded. There was concern that the flood crest might top the reservoir dam; all spillway gates were opened to their maximum discharge of up to 130,000 cubic feet per second (**figures 97–98**), as compared to the normal rate of 9,200 cubic feet per second. Trailer homes below the spillway were soon flooded. As residents were trying to save their belongings, people lined the spillway side of the dam to fish (**Figure 99**). Flood water then moved up tributaries to flood subdivisions in northeast Jackson, including the expensive

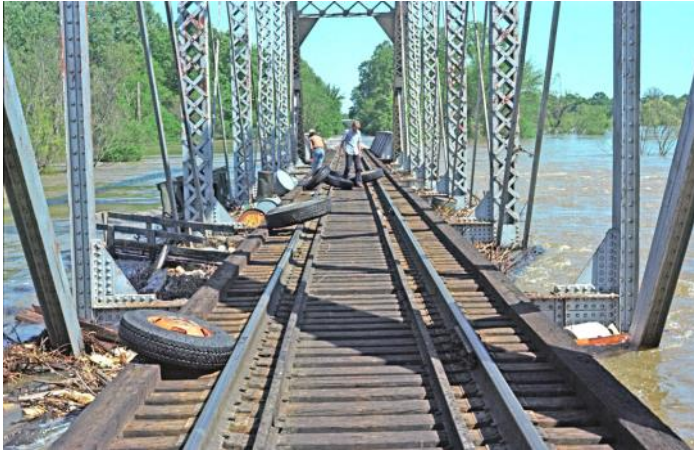
Figure 108. Flood debris accumulates against a railroad bridge over the Pearl River in south Jackson. The bridge is submerged in the distance. Tires with wheels on the bridge are being salvaged. Picture (scanned negative 416-11C; Image 1909) was taken on April 15, 1979.

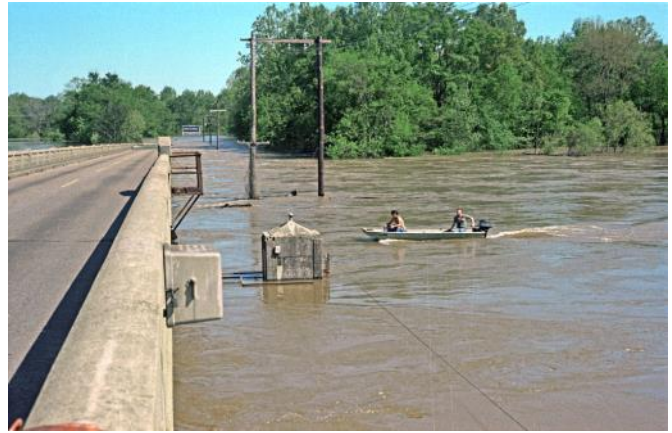
Figure 109. Dangerous boat ride in a jon boat against strong currents and with low clearance under the Woodrow Wilson Bridge over the Pearl River in south Jackson. The bridge is submerged in the distance. Picture (scanned negative 416-20C; Image 1910) was taken on April 15, 1979.

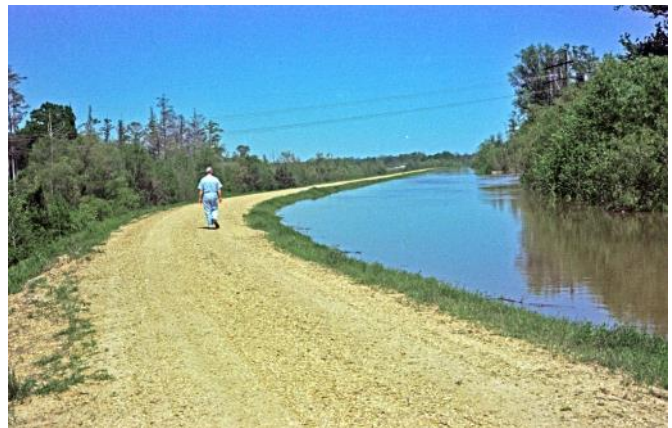
Figure 111. David Dockery Jr. walking the south end of the Jackson levee as flood waters near the levee's top. After a modest walk, my father (Jr.) and I worried that we might be trapped should the levee be overtopped behind us. Picture (scanned negative 416-C; Image 1912) was taken on April 15, 1979.

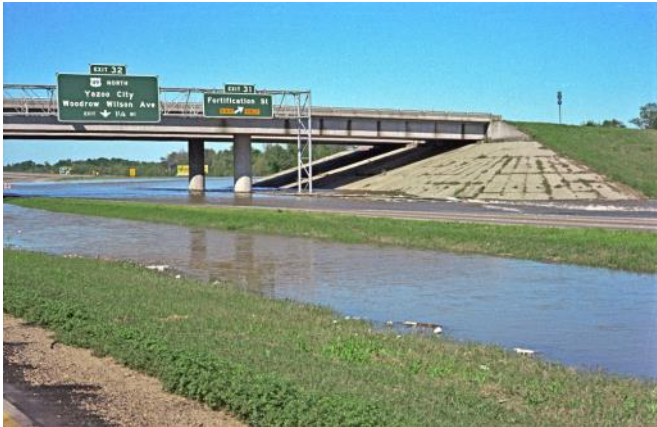
Figure 112. Flood waters pour across the north end of the Jackson levee and cascade south down Interstate 55 at Fortification Street Exit 31. Picture (scanned negative 416-24C; Image 1913) was taken on April 15, 1979. Picture continues to the right in Figure 85.

The State Fairgrounds area, which was protected by the Jackson levee, experienced backwater flooding through manholes of a 66-inch sewer line built only four years earlier in 1975. This line carried sewage from north Jackson to the sewage treatment plant in Byram. To do so, it penetrated the Jackson levee and crossed the flood waters of Town Creek. On Sunday, April 16, flood water was near the top of the Jackson levee (**Figure 111**). Before topping the levee, the water found the lowest point on the levee's north end and overflowed the Interstate 55 Exit 31 ramp at Fortification Street, flowing down the interstate as if it were a river (**figures 112-116**).

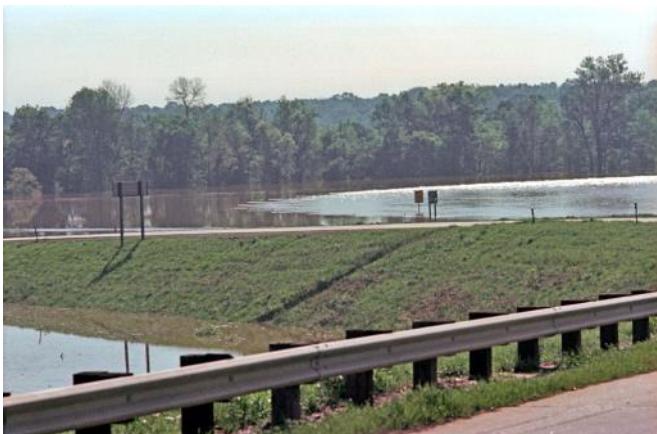
Figure 114. Placid floodwaters, which overtopped the north end of the Jackson levee, break into rapids over the Interstate 55 Exit 31 ramp at Fortification Street before flowing south down the interstate. Picture (scanned negative 415-6C; Image 1915) was taken on April 17, 1979, the day of the flood crest.

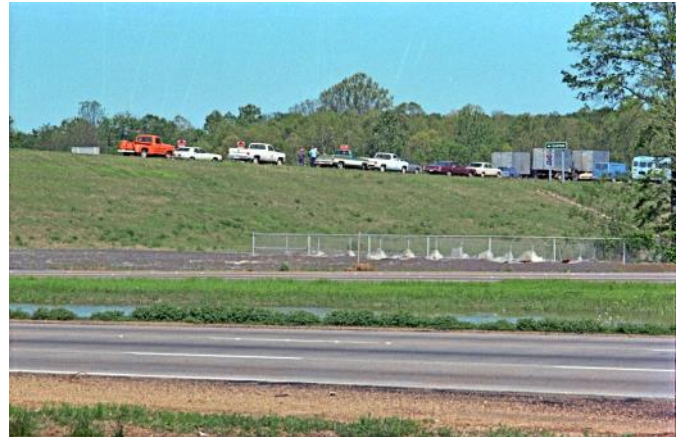
Figure 113. Flood waters overtop the north end of the Jackson levee at the Interstate 55 Exit 31 ramp at Fortification Street. Highway Department personnel and others watch helplessly as a late effort to sandbag the levee was unsuccessful. Water flowing down the interstate crashes against the interstate right-of-way fence. Picture (scanned negative 416-25C; Image 1914) was taken on April 15, 1979.

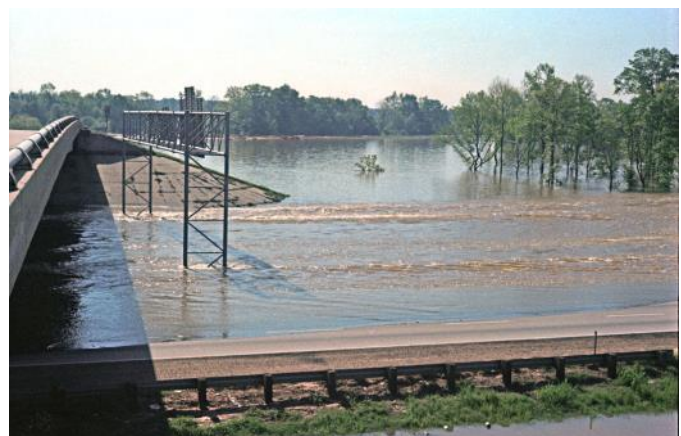
Figure 115. Flood waters overtopping the north end of the Jackson levee flow south like a river down Interstate 55 into the State Fairgrounds area. Picture (scanned negative 415-9C; Image 1916) was taken on April 17, 1979, the day of the flood crest.

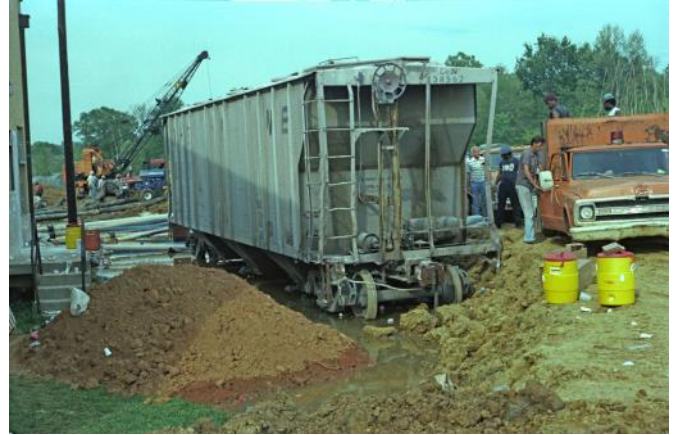
Figure 117. An improvised levee hurriedly built around Jackson's Water Treatment Plant strands a rail-car inside the levee. Picture (scanned negative 415-33C; Image 1918) was taken on April 15, 1979.

Flood waters inundated and shut down three of the city's power substations. Two others, including one on Jefferson Street that powered the downtown area, were saved by improvised levees. Flood waters also overwhelmed the city's sewage treatment plant, mixing raw sewage with river water, and threatened to cut off the city's public water supply by flooding the Jackson Waterworks. To save the Waterworks, a makeshift levee was built around the facility (**Figure 114**). Still, the system's intake pumps were flooded and inoperable. To replace them, tractors powering mechanical pumps and diesel water pumps were used to pump river water into the waterworks (**Figures 118-120**).

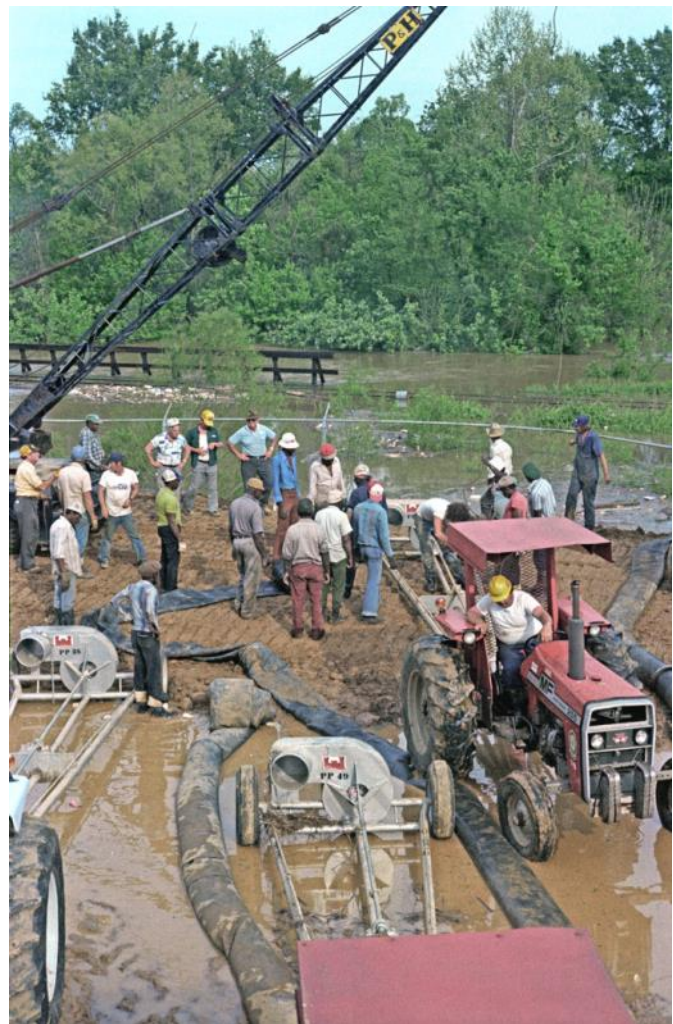
Figure 118. At right, tractors power mechanical pumps to supply river water to the Jackson Water Works Plant. Picture (scanned negative 415-35C; Image 1919) was taken on April 15, 1979.

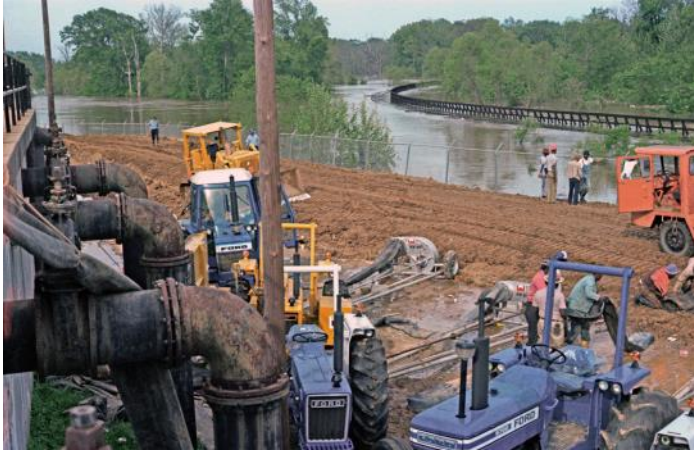
Figure 119. Pumping temporarily ceases as more dirt is added to raise the levee around the Jackson Water Works Plant. A limp rubber hose tied to the top of the Water Works wall can be seen at left draped around the metal pipe. In the background is a flooded railroad bridge. Picture (scanned negative 415-34C; Image 1920) was taken on April 15, 1979.

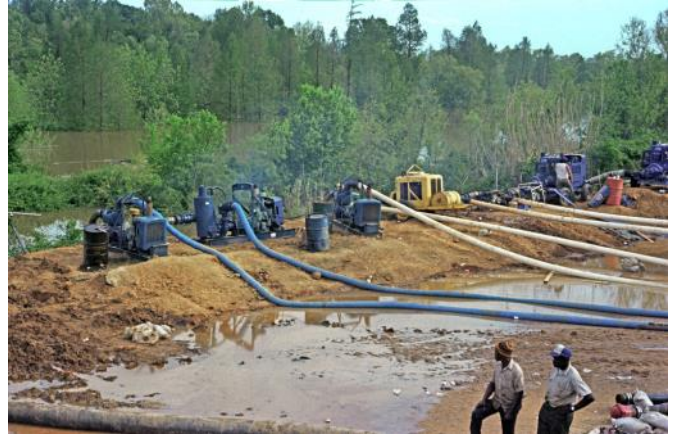
Figure 120. Diesel pumps are added to the mix of tractor-powered pumps to supply the Jackson Water Works with a steady flow of river water. Picture (scanned negative 415-36C; Image 1921) was taken on April 15, 1979.

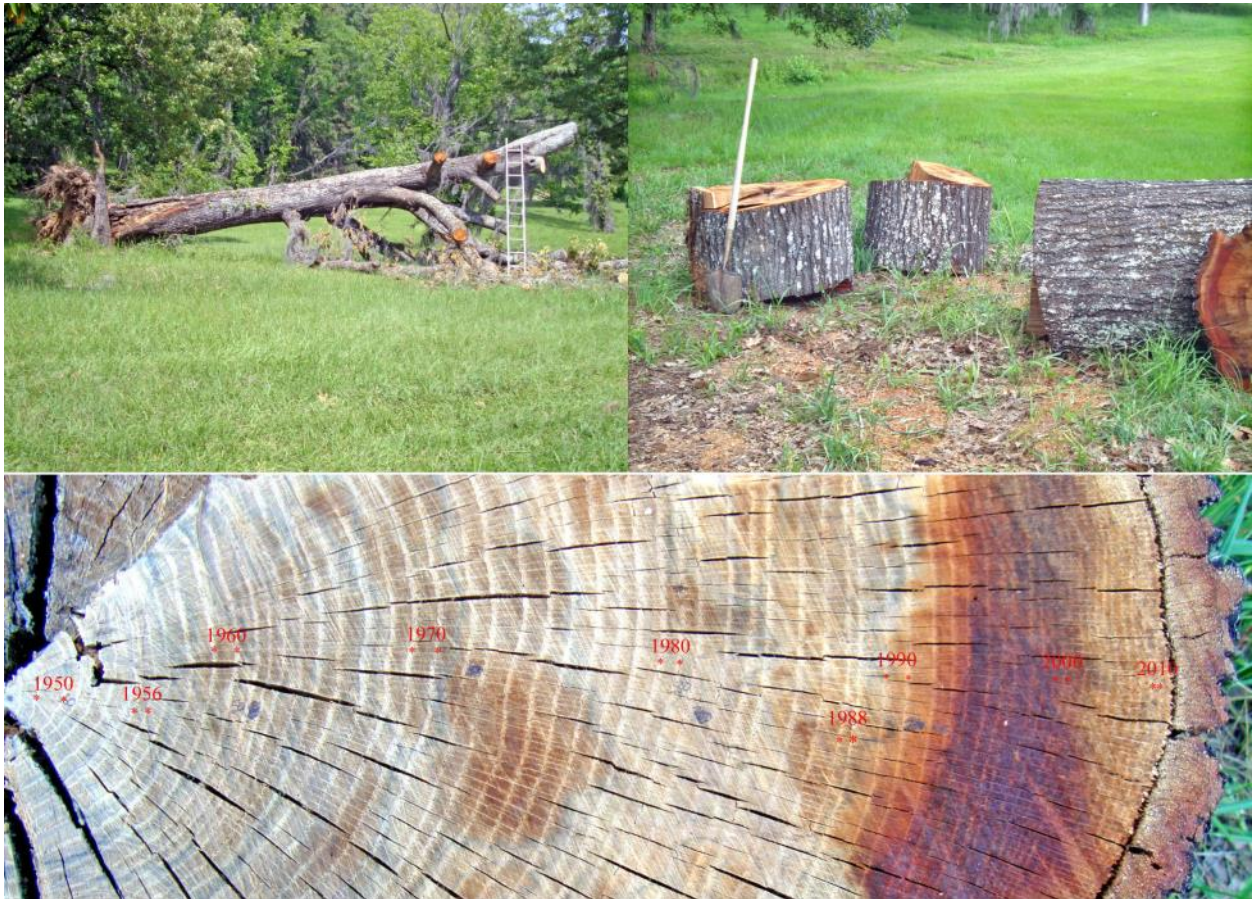
Figure 123. Red oak tree in northwestern Hinds County that fell on March 22, 2012, with leaves fully grown; the last ring on the tree was made in 2011. The bottom picture was taken on June 22, 2012, and has the rings marked by decades from 1950 to 2010. Also marked are the drought years of 1956 and 1988. Picture (digital; Image 2251).

Figure 123 shows the process of cutting up the fallen tree and a cross section of the trunk with rings labeled by decades from 1950 to 2010. The drought years of 1956 and 1988 are also labeled. The last decade of tree growth was slower with smaller rings probably due to an area of growing rot at the base of the tree. The 1988 ring stands out as much smaller than the rings before or after. Drought years of 1980-1982 affected the northern part of the state and are not recorded in this tree’s rings. Even so, the effect of the 1980-1982 drought

on Mississippi agriculture led to the creation of an entirely new water law in 1985 (House Bill 762 and 149). The ring for the drought year of 1956 is unremarkable, while the 1955 ring is very small.

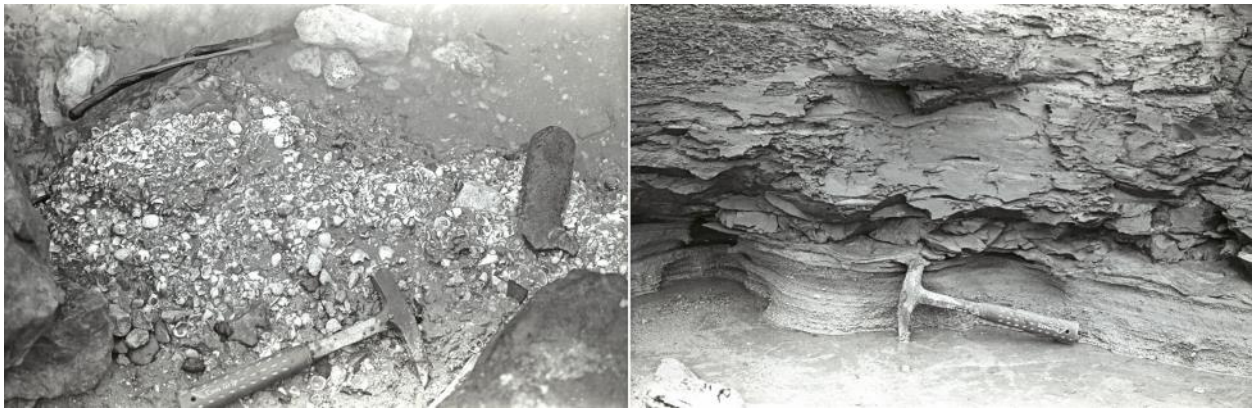
Figure 127. Left, shell lag deposit at the base of the Mint Spring Formation with clay ripup clasts from the underlying Forest Hill Formation on the Mississippi River at Vicksburg. Right, clay of the upper Forest Hill Formation seen only at very low river levels. Pictures (scanned negatives at left 220-5 and at right 220-15; Image 2255) were taken in January of 1981.

per Forest Hill Formation. All of these formations were exposed in late January and early February of 1981 when the Mississippi River fell below the zero mark on the Vicksburg river gage (**Figure 126**). **Figure 127** shows the basal shell lag of the Mint Spring Formation (left) and the underlying clay of the upper Forest Hill Formation (right).

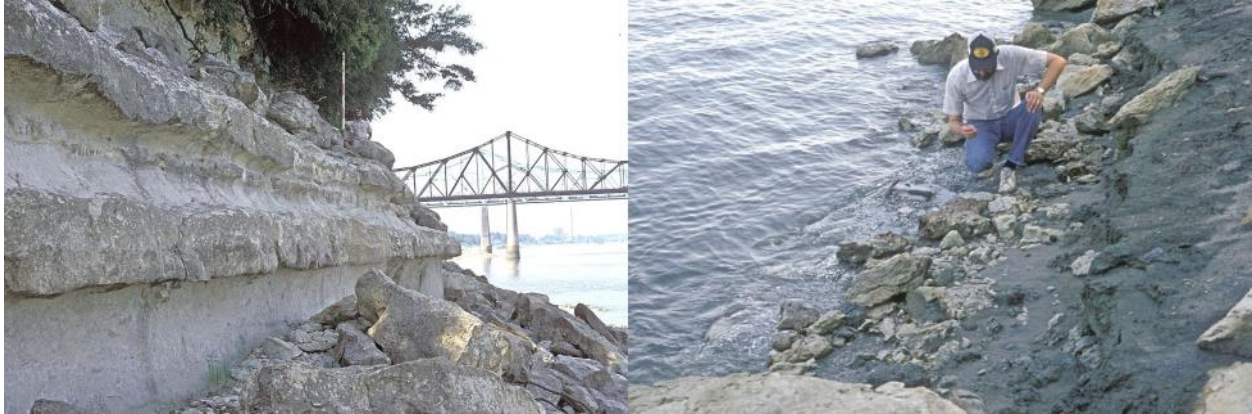
Figure 128. At left, Michael Bograd with survey rod standing on the Glendon Limestone during low water on the Mississippi River at Vicksburg during the drought of 1988. The Marianna Limestone is exposed below the lower ledge of Glendon Limestone. At right, Michael Bograd standing at river level on the basal shell lag of the Mint Spring Formation. Pictures (left, slide 207-20; right, slide 207-4; Image 2256) were taken on June 28, 1988.

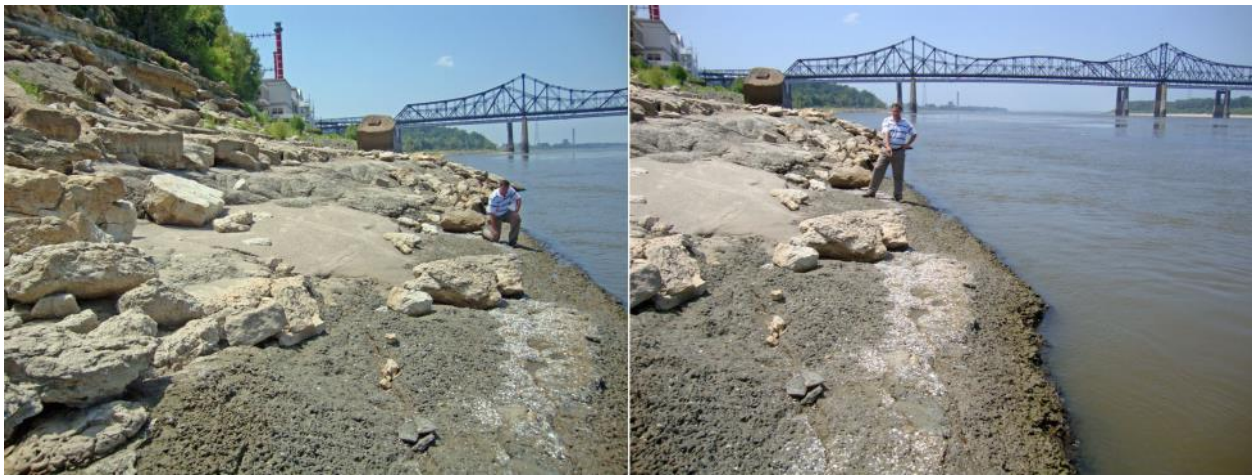
Figure 129. Left, James Starnes kneeling on the basal shell lag of the Mint Spring Formation on the Mississippi River at Vicksburg, with the overlying Marianna and Glendon limestone section to the left. At right, James Starnes standing on the basal shell lag of the Mint Spring Formation on the Mississippi River at Vicksburg, with the Highway 80 and Interstate 20 bridges at right. The river stage was at 1.6 feet at Vicksburg. Picture were taken on July 30, 2012; Image 2257.

Figure 129 shows low water on the Mississippi River at Vicksburg, Mississippi, during the drought of 1988. At left in the figure, Michael Bograd stands on an exposed sec-

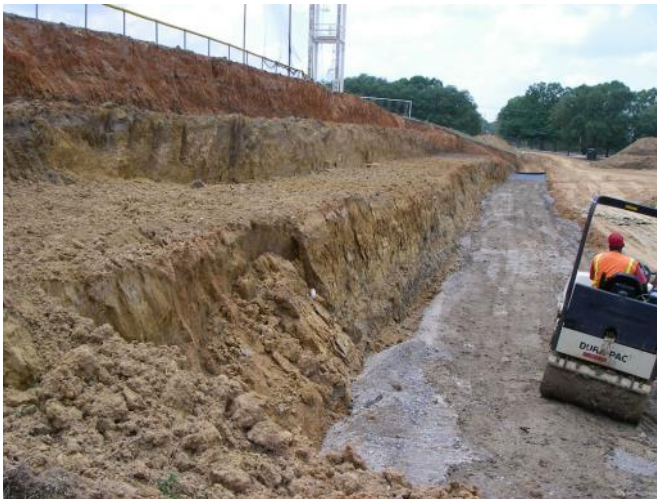
Figure 130. Excavation for a new football field at Millsaps College at Jackson, Mississippi. The lower two tiers in the foreground consist of weathered Yazoo Clay. The upper tier is terrace sand, which drapes over the Yazoo Clay of the bottom tiers in the distant hillside. The crushed limestone floor is the foundation for a retaining wall. Extra stone is placed at the base of a small slump in the foreground. Picture (digital, CD 41; Image 1010) was taken on May 23, 2007.

of significant drought, which masked the problem of subsurface drainage from the upper field. A two-meter-high retaining wall, consisting of 2,000 pound concrete blocks fitted together like LEGO toys, was placed at the base of the cut hillside above a foundation of crushed limestone. **Figures 130-123** illustrate the geologic conditions in the freshly cut hillside; the three cut benches in the picture consist of a red terrace sand in the upper bench and weathered Yazoo Clay in the lower two benches. The terrace sand underlying the upper football field could not drain through the clay below, but only out the hillside. The underlying Yazoo Clay is the infamous, swelling, foundation destroying, road buckling, wall splitting, bane of the Jackson area. The Mississippi Office of Geology has published an

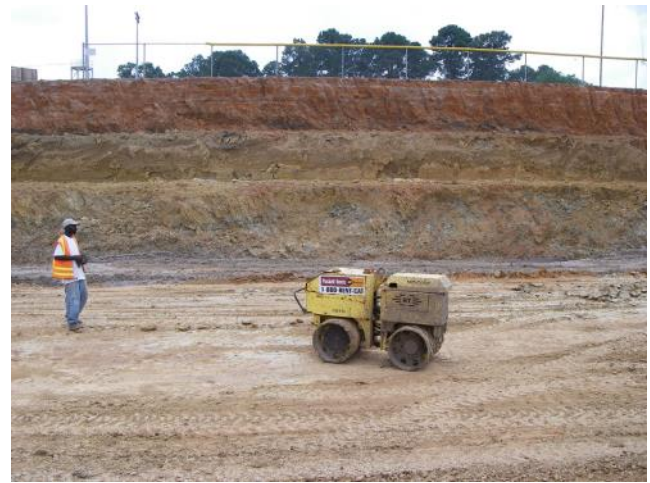
Figure 131. Excavation for a new football field at Millsaps College. The lower two tiers in the high-wall cut consist of weathered Yazoo Clay and the upper tier is a terrace sand deposit. The crushed limestone floor at the foot of the cut is the foundation for a retaining wall. Picture (digital, CD 41; Image 1087) was taken on May 23, 2007.

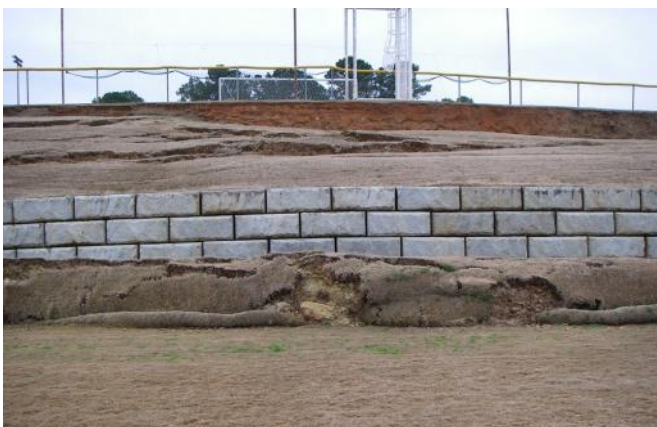
Figure 132. Slump in Yazoo Clay pushed the retaining wall up and out as seen from the new football field at Millsaps College in Jackson, Mississippi. The slump scarp cuts near the observation tower of the upper field, and the toe is elevated in front of the retaining wall like a roll of carpet. Picture (digital, CD 42; Image 1011) was taken on January 31, 2008.

Figures 132-133 show the spectacular failure of the retaining wall after the return of winter rains. While the wall held together, it did not stay put. At the top of the picture is the slump scarp, which threatened the filming tower and the upper field, and below is the slump's toe, which rose some five feet high

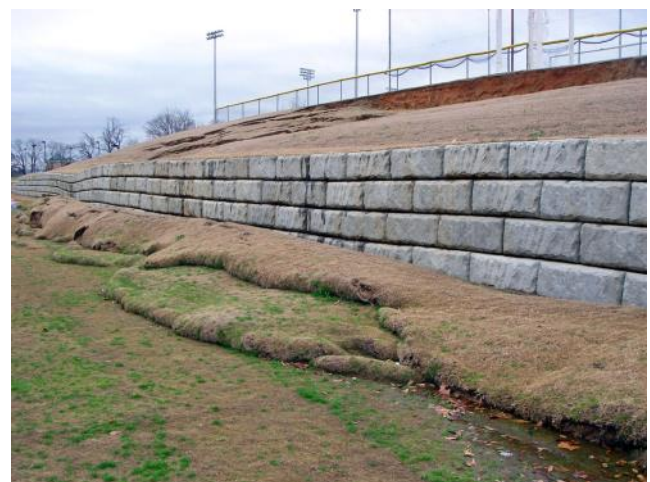
Figure 133. The manicured grass field at the toe of the slump, protruding from beneath the retaining wall at Millsaps College, looks like rolls of carpet. Picture (digital, CD 42; Image 1923) was taken on January 31, 2008.

from the edge of the lower playing field. With the manicured grass surface, the toe looks like a roll of carpet (**Figure 133**). Before the Saints arrived for training camp, the displaced retaining wall needed to be rebuilt and the practice field repaired. The geotechnical firm of Burns Cooley Dennis, Inc., was employed to design a new retaining wall. **Figure 134** shows the drilling of a hole through the slump to determine the base of the failure surface or shear plane. Once the depth of the failure sur-

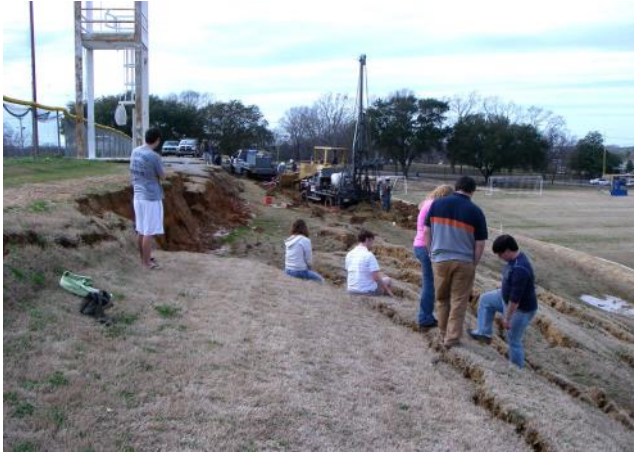
Figure 134. Millsaps geology students watch as an auger rig drills a hole to determine the base of the slump block adjacent to the new football field at Millsaps College. Picture (digital, CD 42; Image 1012) was taken on February 20, 2008.

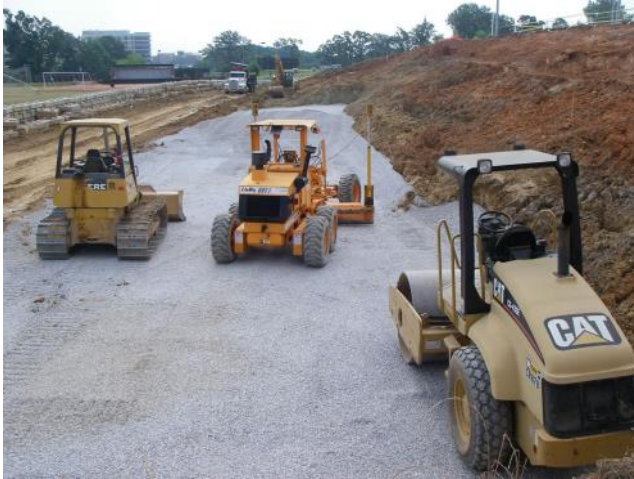
Figure 136. Construction of a 230-foot-long crushed limestone keyway to disrupt the basal shear plane of the slump at Millsaps College. Picture (digital, CD 46; Image 1031) was taken on June 17, 2008.

face was known, the wall had to be removed block by block (**Figure 135**), the Yazoo Clay in the slump block had to be excavated and removed, and a crushed limestone keyway was built through the failure surface to prevent further movement (**figures 136-137**). **Figures 138-139** show Burns Cooley Dennis' engineering plans for the construction of the new retaining walls, and **Figure 140** shows a construction-schedule conference with concerned representatives from the college, the construction firm, the engineering firm, and the Saints.

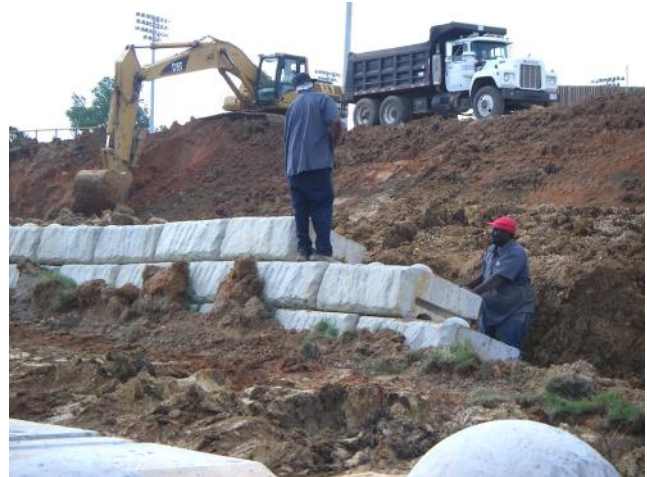
Figure 135. Excavation of slump block and removal of the tilted retaining wall. Each concrete block in the wall weighs 2,000 pounds and is fastened by dome and socket joints. Removed blocks are stacked in the foreground for reassembly later. Picture (digital, CD 42; Image 1013) was taken on June 4, 2008.
